Manhole Inspection Summary

Manhole # S41CC_040MH

Insp Date: **12/12/07 8:49 AM**

Location Address: **eden and eager park alley**

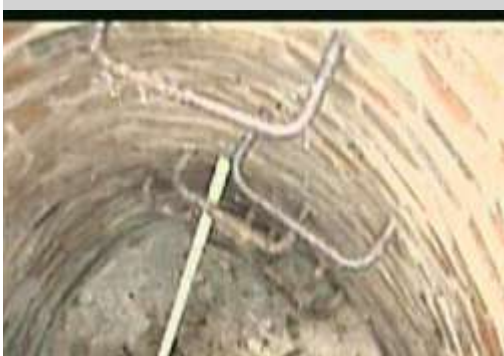
Defect 1

Count: **8** Missing: **0** ☒ Corroded

steps

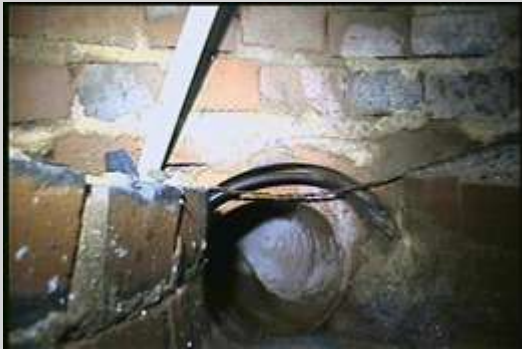
8 in. Circular Gravity Sewer
Pipe In @ 5 O'Clock

12 O'Clock Outflow

Pipe Material: **Clay** ☐ Pipe Lined

Invert Depth: 11.30 (ft.) Flow Characteristics: **Slow**

Infiltration: **None** Pipe Seal Cond: **Unknown**

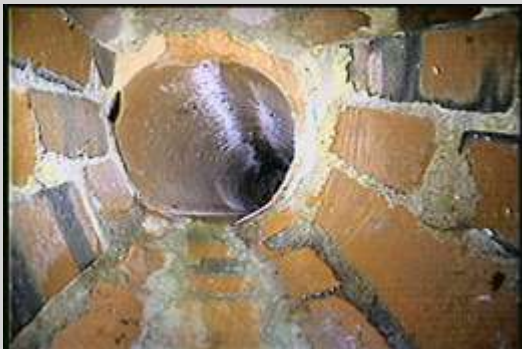
8 in. Circular Gravity Sewer
Pipe Out @ 12 O'Clock

8 O'Clock Inflow

Pipe Material: **Clay** ☐ Pipe Lined

Invert Depth: 10.00 (ft.) Flow Characteristics: **Slow**

Infiltration: **None** Pipe Seal Cond: **Unknown**
